INDOOR AIR QUALITY ASSESSMENT

**Luther Burbank Middle School
1 Hollywood Drive
Lancaster, Massachusetts**

Prepared by:
Massachusetts Department of Public Health
Center for Environmental Health
Emergency Response/Indoor Air Quality Program
August 2005

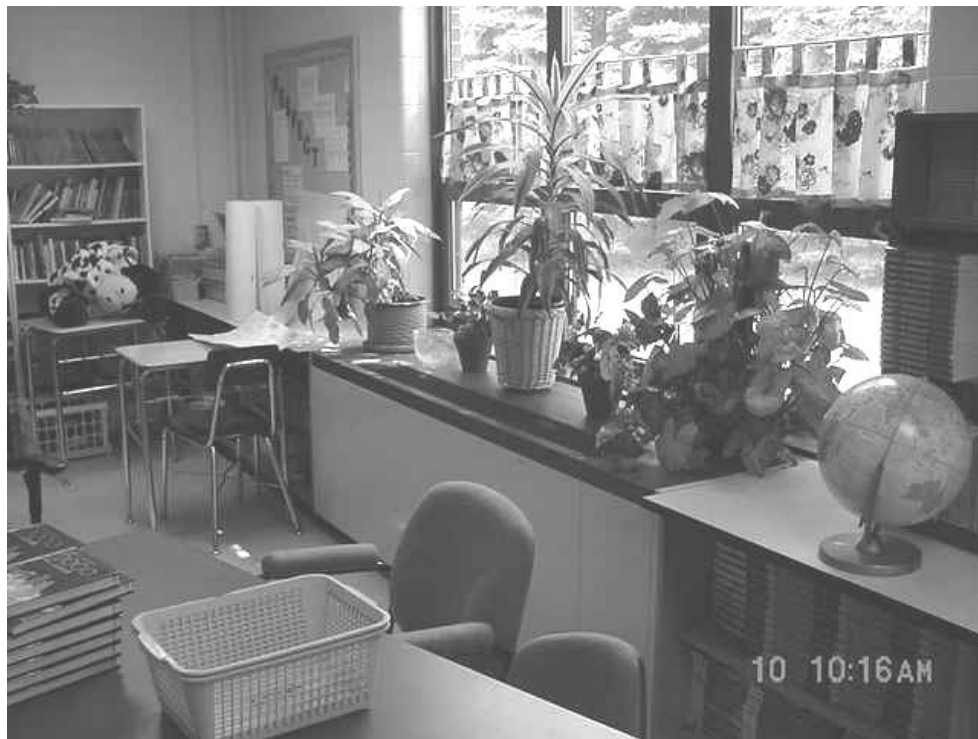
Picture 1

In addition to floor tiles, several other potential sources of mold growth were identified. Plants were noted in several classrooms and in close proximity to univent air intakes outside the building (Pictures 1 and 2). Plants can be a source of pollen and mold, which can be respiratory irritants for some individuals. Plants should be properly maintained and equipped with drip pans. Plants should also be located away from ventilation sources (e.g., air intakes, univent diffusers) to prevent the entrainment and/or aerosolization of dirt, pollen or mold.

Classroom Univent, Note Plants on top of Univent near Air Diffuser

8. Extend condensation drains in courtyard away from building.
9. Move plants away from univents in classrooms. Ensure all plants are equipped with drip pans. Examine drip pans for mold growth and disinfect areas of water leaks with an appropriate antimicrobial where necessary.

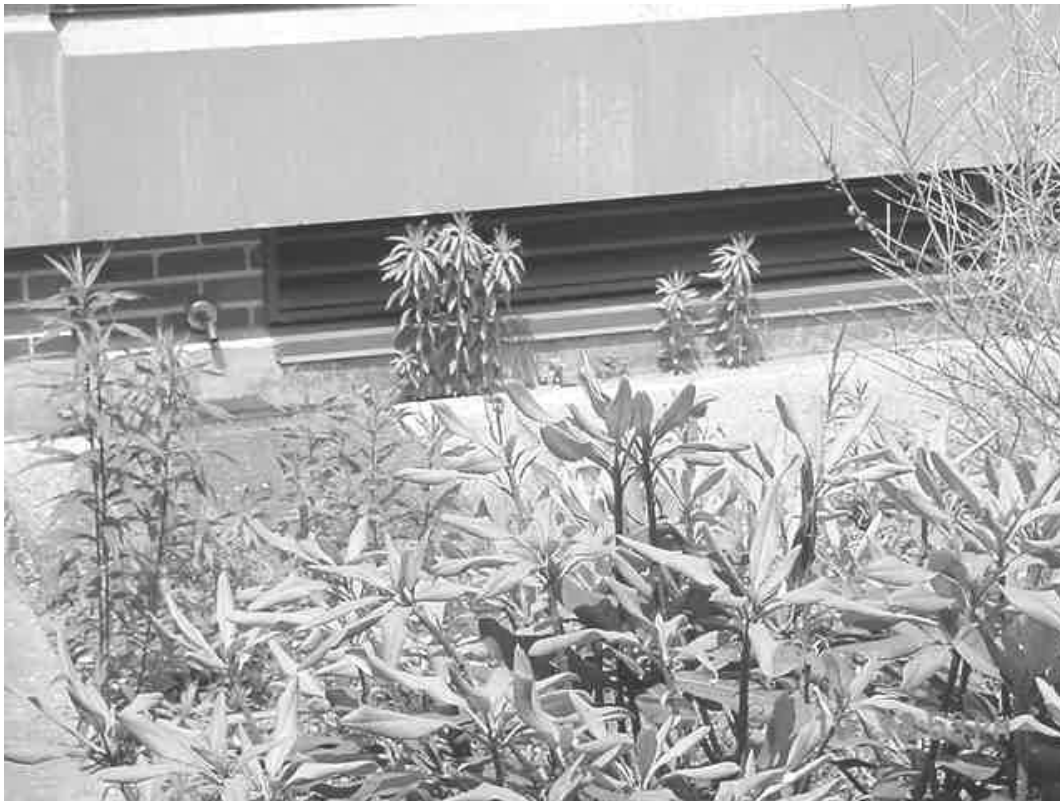
Picture 2

Univent Fresh Air Intake, Note Plant Growth

10. Remove plant growth from the vicinity of exterior walls and univent air intakes around the perimeter of the building.
11. Contact a masonry firm or general contractor to repair holes/breaches in exterior walls/joints to prevent water penetration, drafts and pest entry.

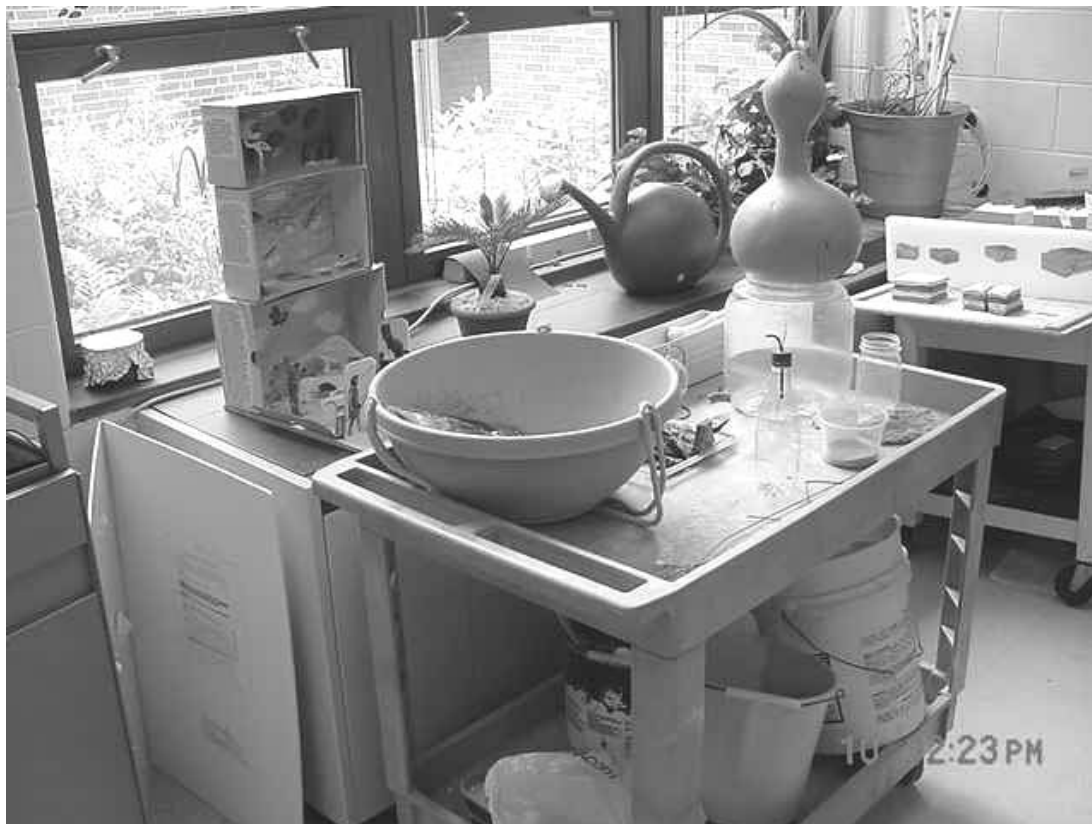
Picture 3

Univent Obstructed by Various Items

2. Close classroom doors to maximize air exchange.
3. Ensure univent air intake controls are adjusted to allow the introduction of fresh air.
4. Remove all blockages from univents to ensure adequate airflow.

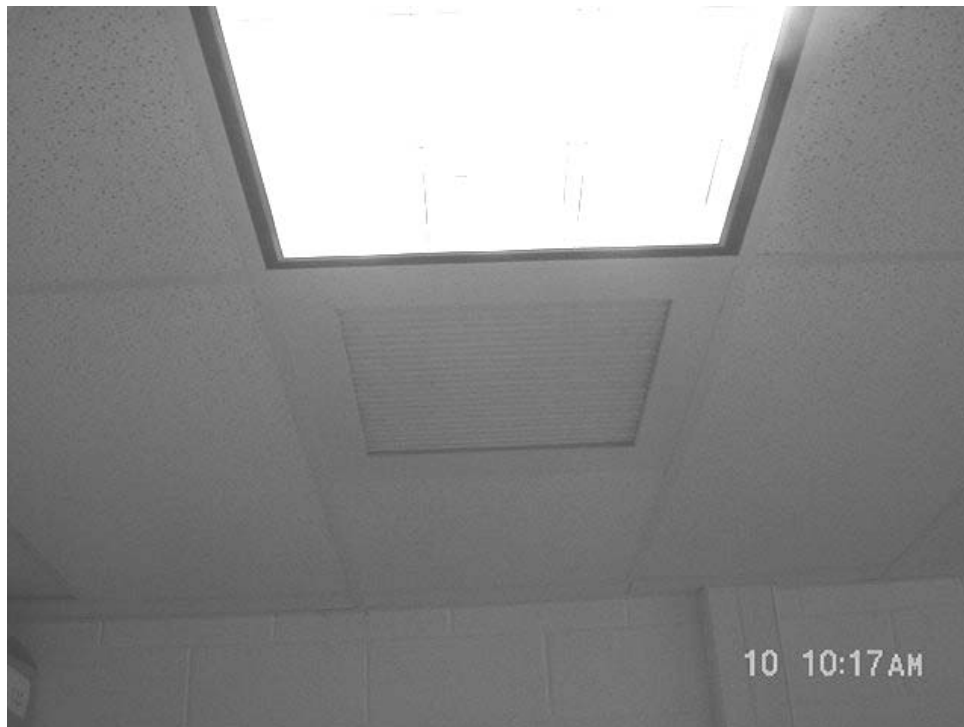
Picture 4

Classroom Exhaust Vent

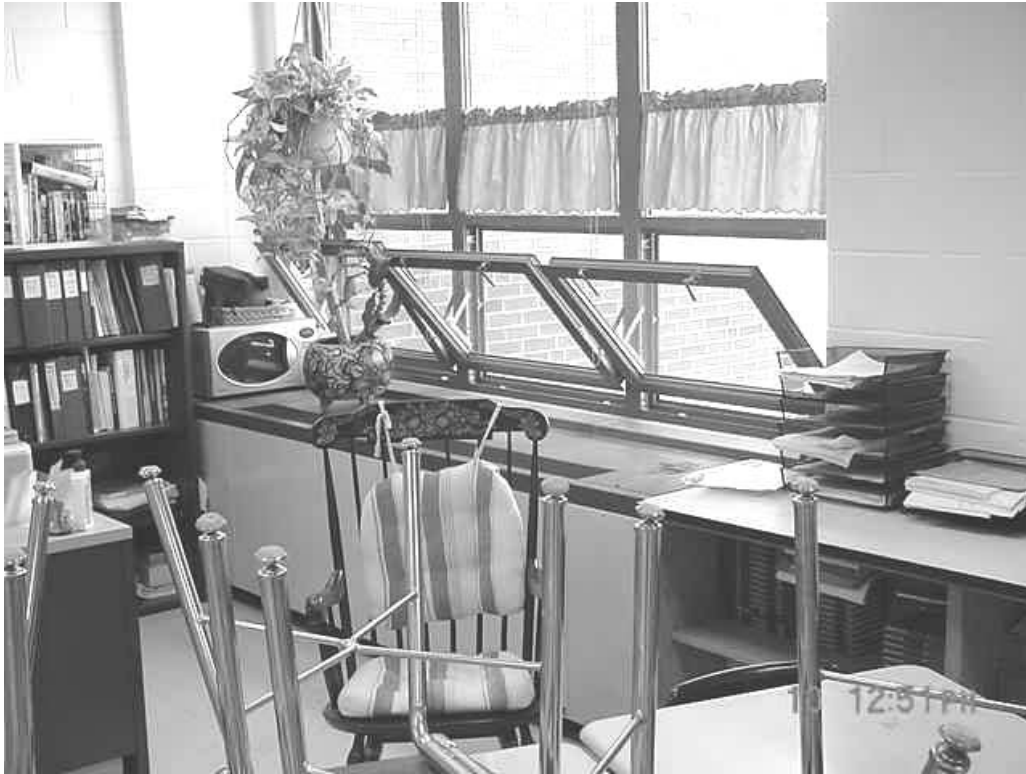
Picture 5

Open Windows in Classroom, Note Air Conditioning was Operating

1. Keep windows closed during hot, humid weather to maintain indoor temperatures and to avoid condensation problems when air conditioning is activated.

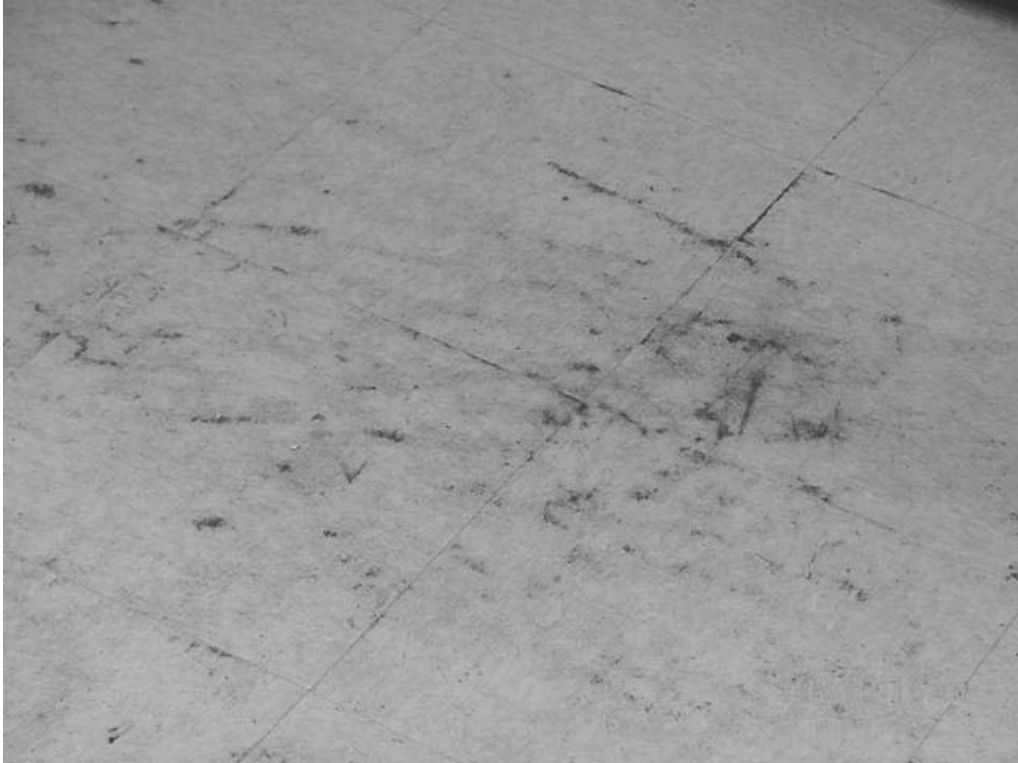
Picture 6

As previously discussed, the assessment was requested due to occupant concerns of stained floor tiles believed to be mold growth. MDPH staff examined stained tiles in affected classrooms. A black gum-like substance was observed on and around seams of floor tiles, which looked like mastic that had oozed from beneath the tiles (Pictures 6 and 7). It was reported by Mr. Sireci that samples of this material had been taken, analyzed and identified as having mold growth. MDPH staff recommended at the time of the assessment that the material be cleaned and disinfected as a temporary measure.

The staining appeared to be more prevalent in high traffic areas in classrooms versus those in low traffic areas. Stained tiles also appeared to be more prevalent in specific areas that had excess mastic leaking/oozing from around tile seams. Since this material is sticky in nature, it may collect dirt, dust and debris, which can provide media for mold growth, especially if wetted repeatedly (e.g., mopping, high humidity over an

extended period/several days). It is possible that the mastic may have been applied incorrectly and/or not according to specifications (e.g., concrete not sufficiently cured), resulting in loss of adhesive integrity.

Dark Staining on/around Floor Tiles

1. Continue with plans to improve drainage around the building to prevent water infiltration damaging floor tiles.
2. Consider removing several tiles in various areas to determine if visible moisture and/or microbial growth are present. If so, the removal of all affected tiles may be

necessary and should be followed by cleaning with an appropriate antimicrobial agent.

3. If continued moisture accumulation/damage to floor tiles in the building recurs after drainage improvements, consideration should be given to having a building engineer examine other potential remediation/prevention strategies.
4. Consider contacting a reputable flooring contractor to remove/replace old tiles and mastic. Slab should be completely cleaned, prepped and sealed using a proper sealant.

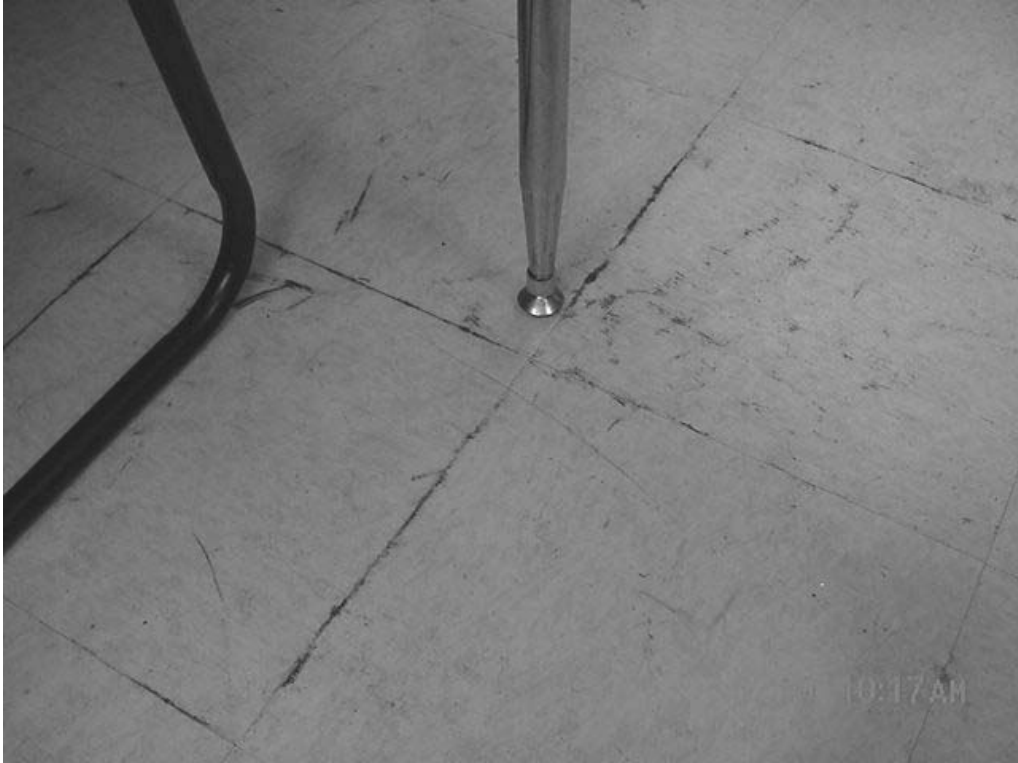
Picture 7

Dark Staining on/around Floor Tiles

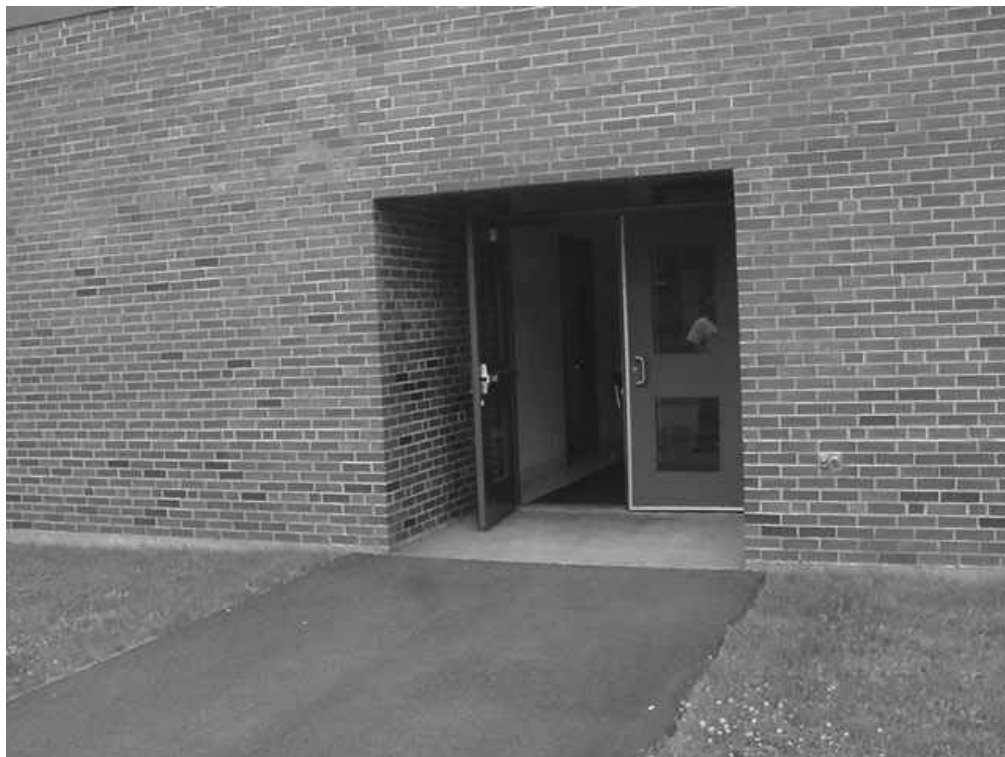
Picture 8

Although water infiltration may be a possible source of moisture impacting floor tiles, high relative humidity during summer months also appears to be a likely source for moisture in the building. Pathways were identified in a number of areas that allow for uncontrolled outside air into the building (see below). Classroom D-135, a corner classroom (Figure 2), had the most prevalent tile staining. During the assessment a number of conditions were observed that could exacerbate the introduction of humid outside air. Directly adjacent to room D-135 is the corridor to the rear exit (Picture 8). The doors are not airtight and had significant spaces below and around the doors that allow for outside air infiltration into the corridor (Picture 9). Once humid outside air is in the corridor, it can be drawn into the classroom by the ceiling-mounted exhaust vent, which is located near the hallway door (Picture 10). This particular door also had significant spaces beneath it (Picture 11). Finally, the hallway door was propped open during the assessment and a box fan was positioned in a manner that would actually draw humid air into the classroom from the hallway (Picture 12).

Exterior Doors outside Room D-135

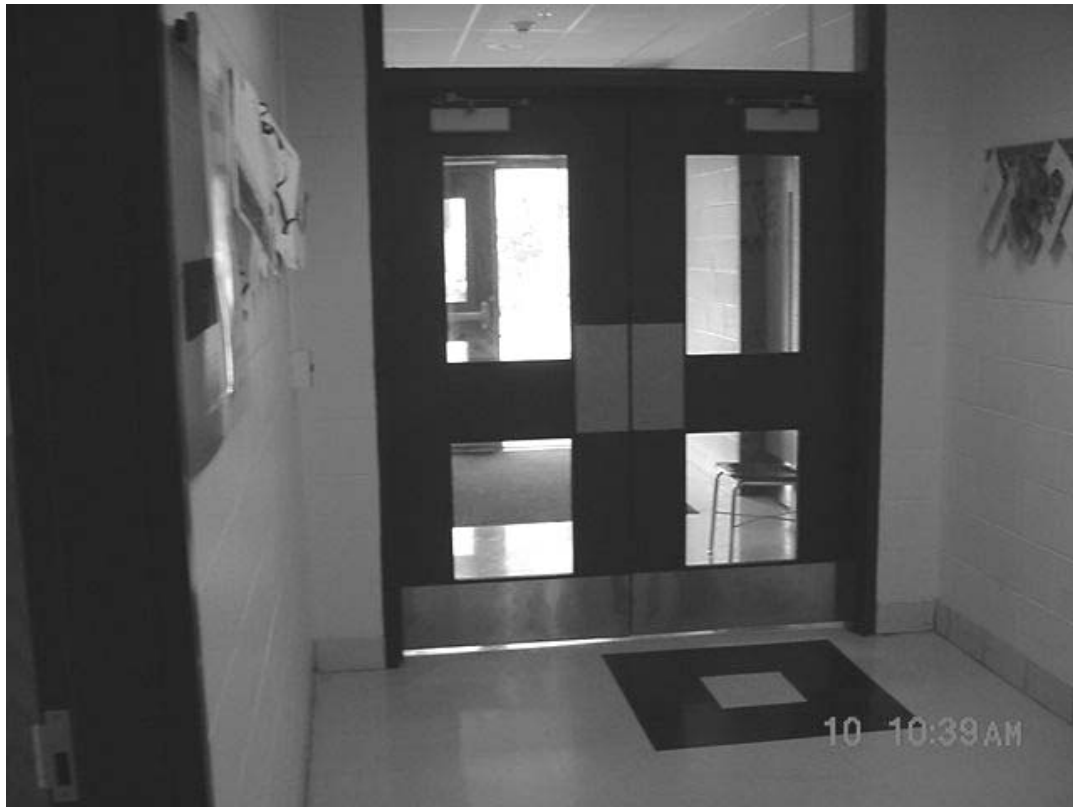
Picture 9

Interior Hallway Doors in Corridor outside Room D-135, Note Spaces beneath Doors

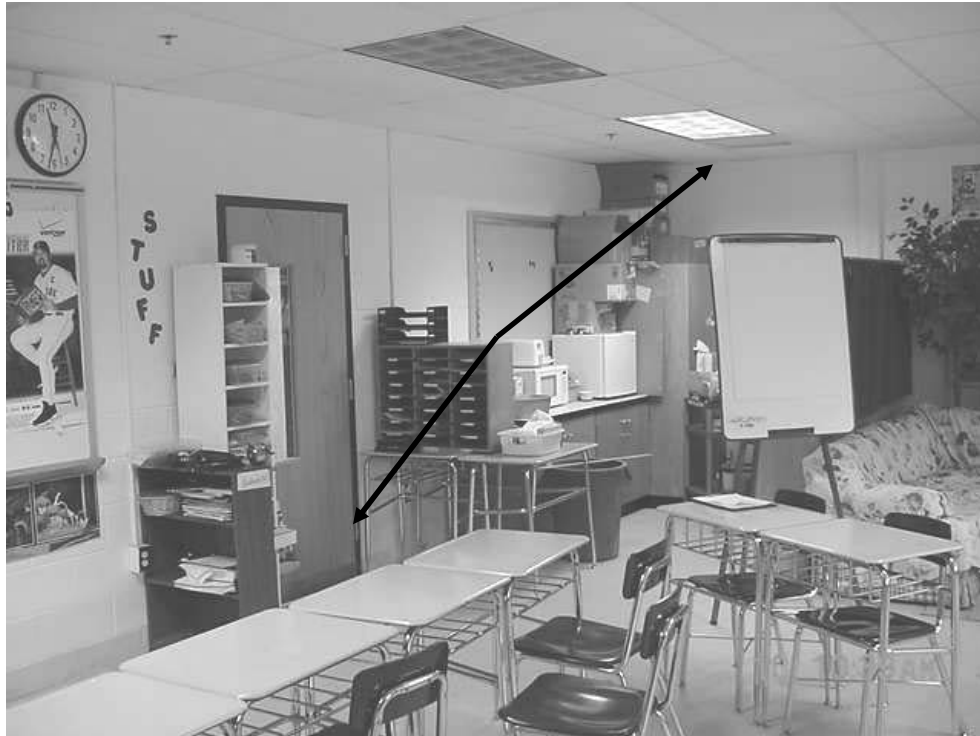
Picture 10

Proximity of Hallway Door and Ceiling-Mounted Exhaust Vent in Room D-135

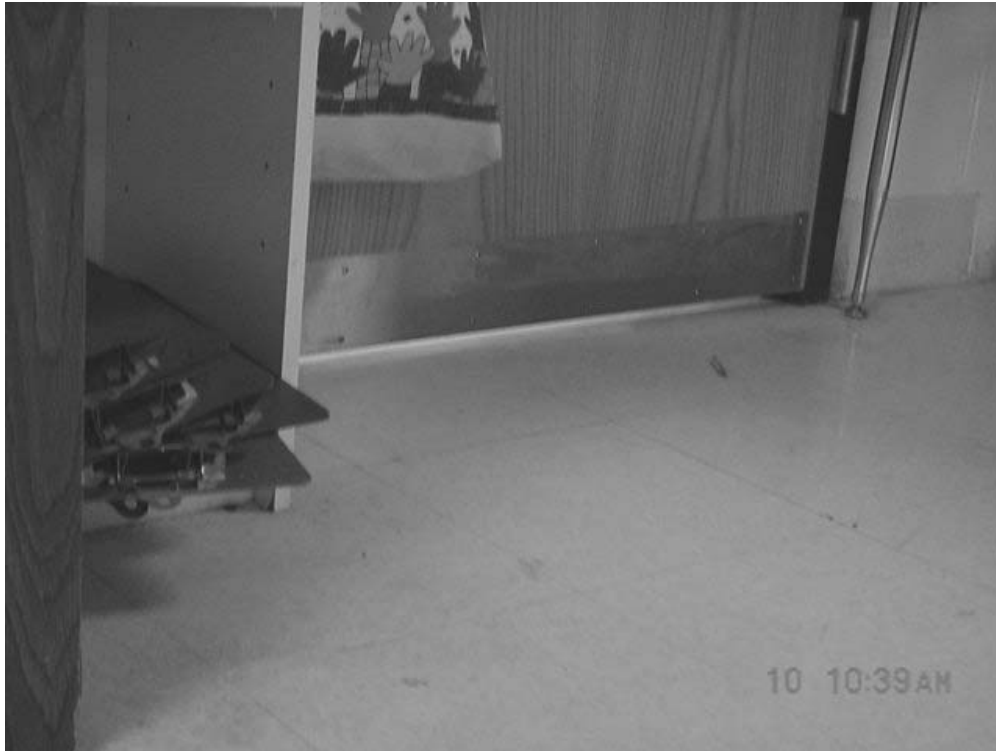
Picture 11

Close-Up of Space beneath Hallway Door in Preceding Picture (D-135)

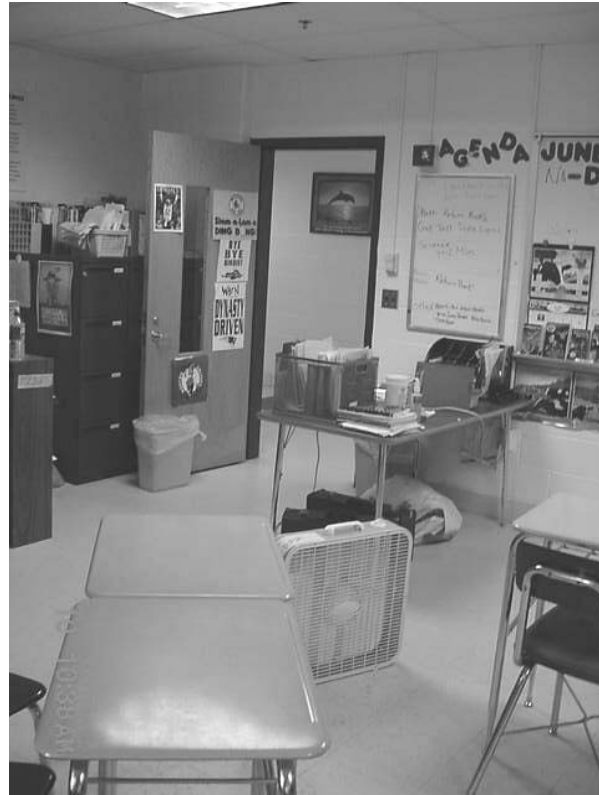
Picture 12

Classroom D-135 Door Propped open, Note Fan Positioned to Draw Air into the Classroom

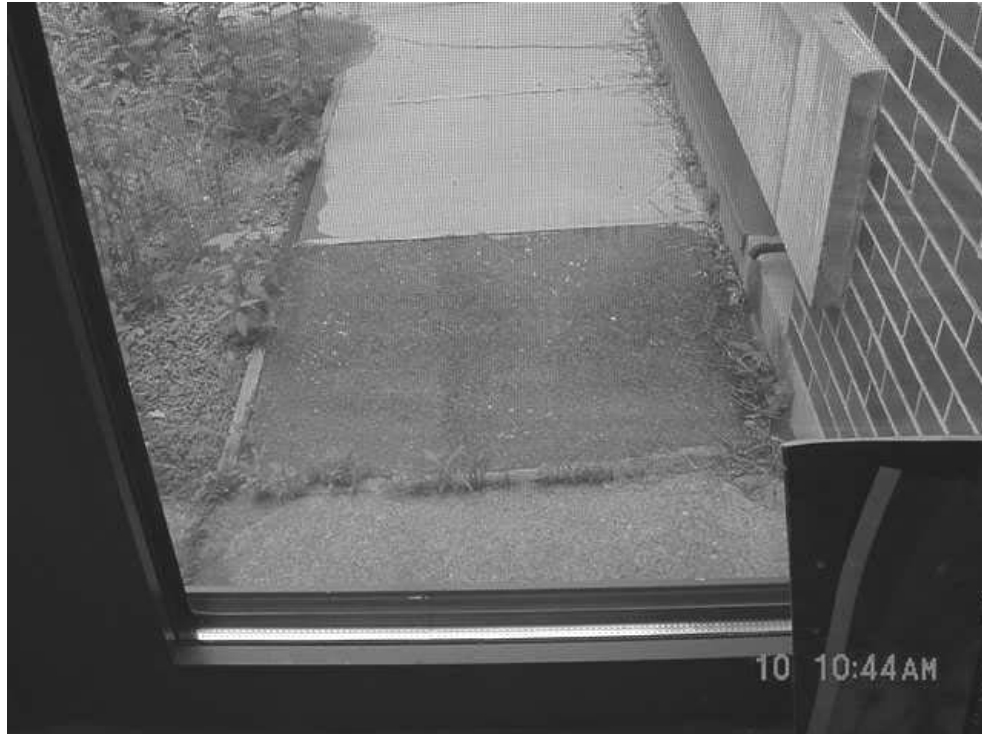
Picture 13

Univents that have air conditioning capabilities customarily are equipped with condensation collection pans and drains. One such drain in the school's courtyard was observed emptying water against the foundation (Picture 13). Excessive exposure to water of exterior brickwork can result in damage over time and provide a source of water penetration.

Wet Tarmac (Dark Area) beneath Univent Condensation Drain

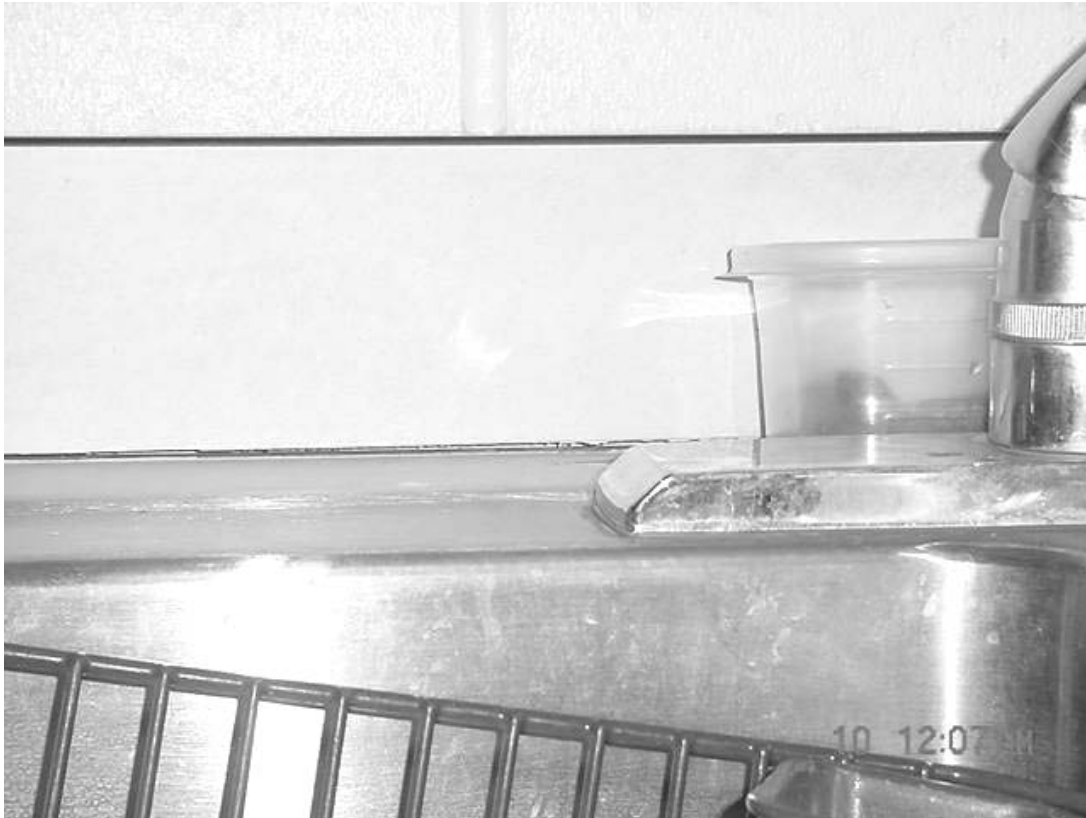
Picture 14

In several classrooms, spaces between the sink countertop and backsplash were noted (Picture 14). Improper drainage or sink overflow could lead to water penetration of countertop wood, the cabinet interior and behind cabinets. Like other porous materials, if these materials become wet repeatedly they can provide a medium for mold growth.

Breach between Sink Countertop and Backsplash

12. Seal areas around sinks to prevent water-damage to the interior of cabinets and adjacent wallboard.
13. Consider discontinuing the use of tennis balls on chair legs to prevent latex dust generation. Alternative “glides” can commonly be purchased from office supply stores; see Picture 19 for an example.

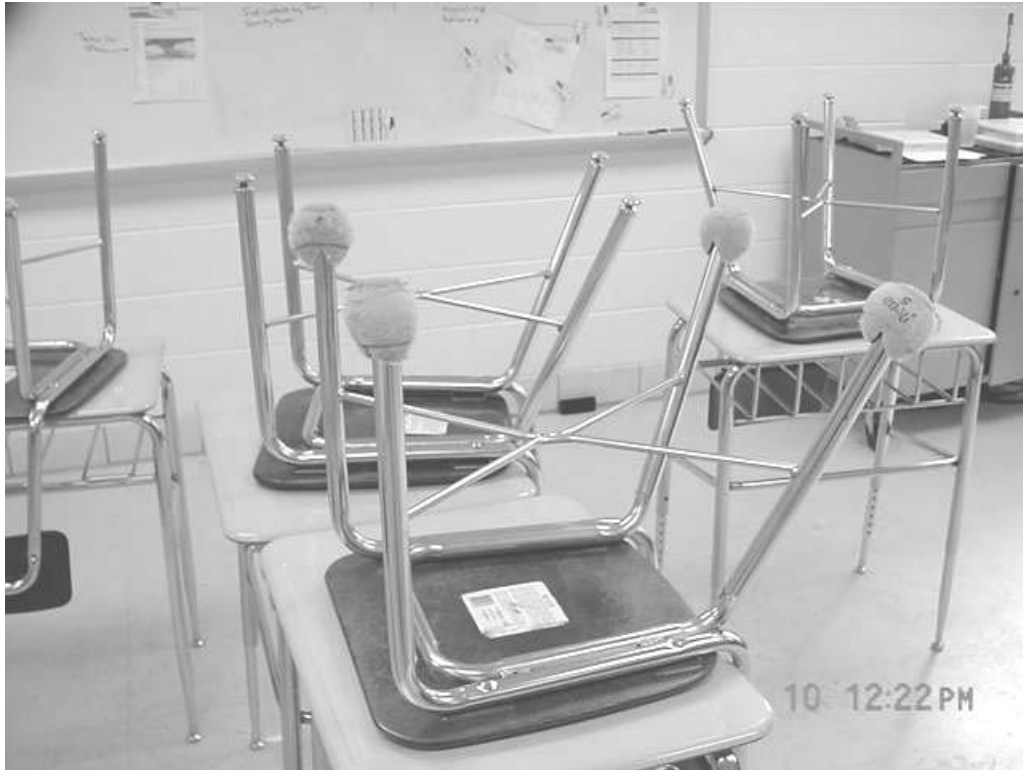
Picture 15

In an effort to reduce noise from sliding chairs, tennis balls had been sliced open and placed on chair legs (Picture 15). Tennis balls are made of a number of materials that are a source of respiratory irritants. Constant wearing of tennis balls can produce fibers and cause TVOCs to off-gas. Tennis balls are made with a natural rubber latex bladder, which becomes abraded when used as a chair leg pad. Use of tennis balls in this manner may introduce latex dust into the school environment. Some individuals are highly allergic to latex (e.g., spina bifida patients) (SBAA, 2001). It is recommended that the use of materials containing latex be limited in buildings to reduce the likelihood of symptoms in sensitive individuals (NIOSH, 1997). A question and answer sheet concerning latex allergy is attached as [Appendix B](#) (NIOSH, 1998).

Tennis Balls on Chair Legs

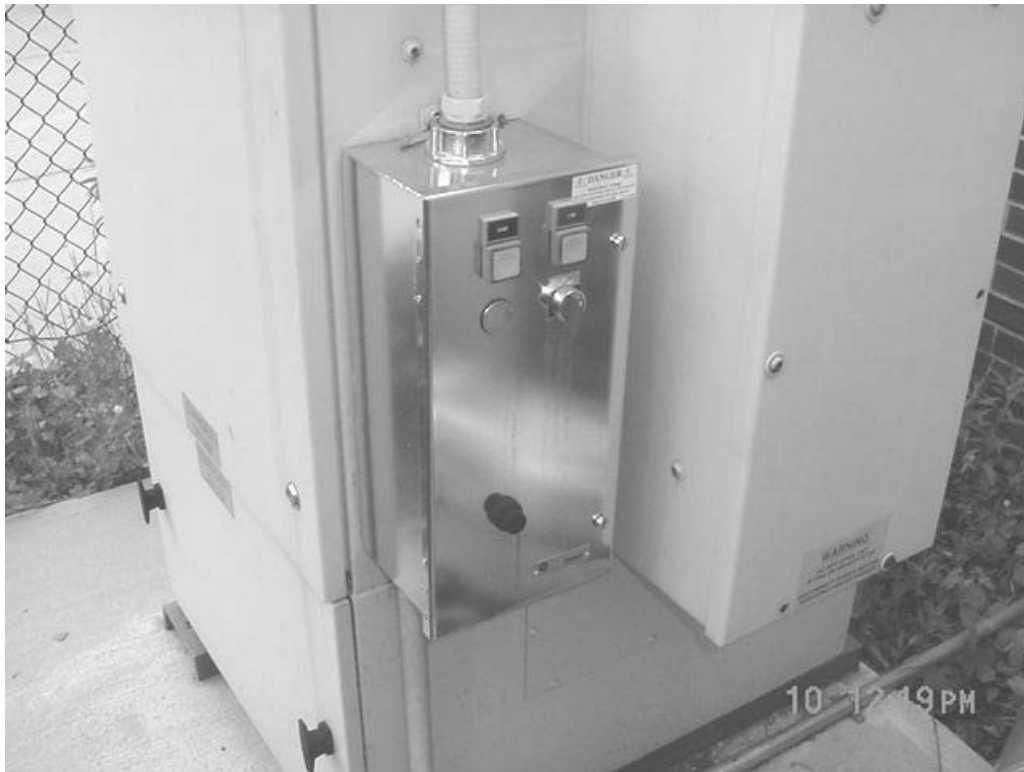
Picture 16

Wood dust and debris were observed around wood working machines and on flat surfaces in the technical education (tech-ed) room. The tech-ed room was outfitted with ductwork to draw materials into a wood dust collection system. However, not all the equipment was ducted. MDPH staff were informed that the system is seldom used because the switch to activate the system is located outside (Picture 16). Wood dust can be irritating to the eyes, nose, throat and respiratory system.

Activation Panel on Wood Dust Collector (Outside Building)

15. Operate wood dust collection system as needed. Consider connecting equipment that is not ducted to the system. Contact a licensed electrician to examine the system to install activation controls *indoors*.
16. Consider adopting the US EPA document, “Tools for Schools”, to maintain a good indoor air quality environment on the building. This document can be downloaded from the Internet at: <http://www.epa.gov/iaq/schools/index.html>.
17. Refer to resource manuals and other related indoor air quality documents for further building-wide evaluations and advice on maintaining public buildings. These materials are located on the MDPH’s website at <http://www.state.ma.us/dph/beha/iaq/iaqhome.htm>.

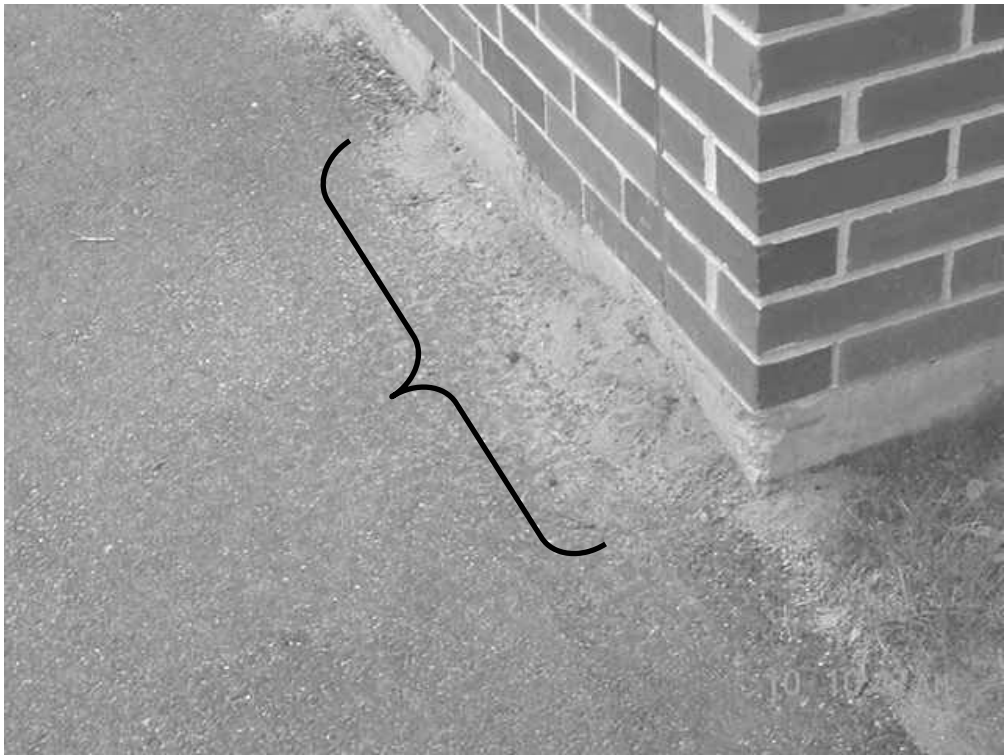
Picture 17

Finally, occupants in room D-132 reported ant infestation. A number of live and dead ants were observed at the base of the interior wall of the classroom. MDPH staff observed conditions on the exterior wall directly outside this area and found ant mounds

against the foundation (Picture 17). Ants were observed entering the building through cracks in the foundation in this area (Picture 18).

Ant Hills against Foundation

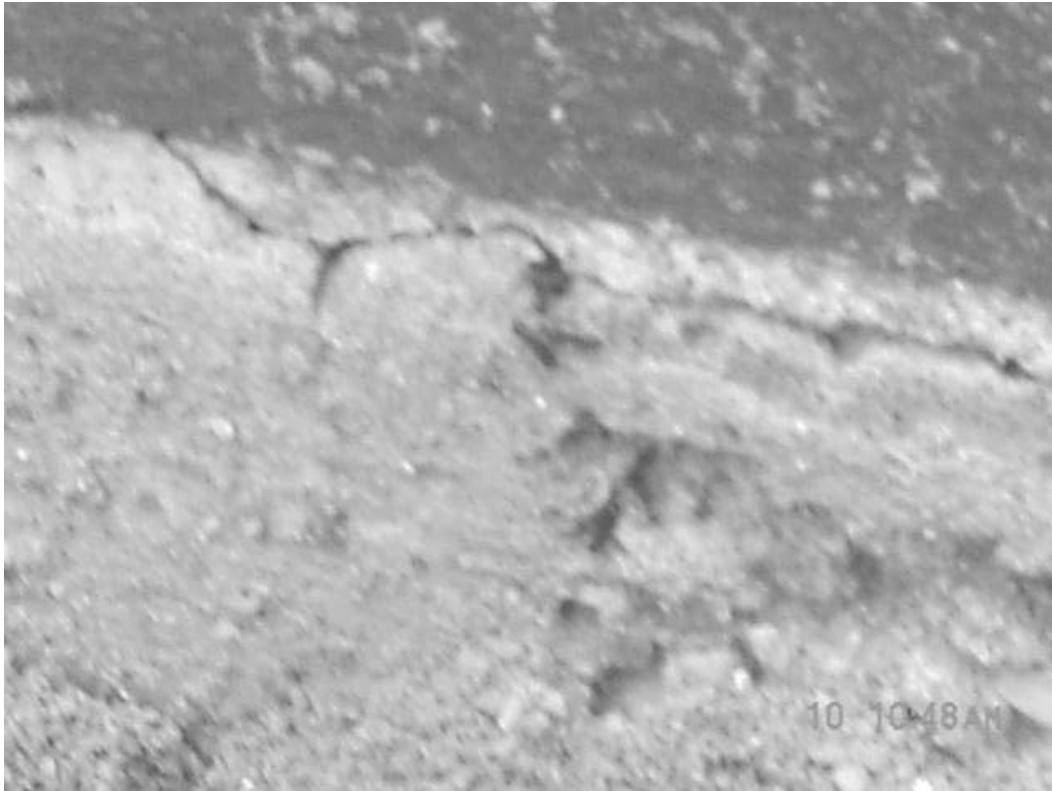
Picture 18

Close-Up of Ants Entering Building through Crack in Foundation
